TS-PIC-93810  
February 1993

# AERIAL PHOTOGRAPHIC ANALYSIS OF THE NASA JET PROPULSION LABORATORY Pasadena, California

EPA Region 9

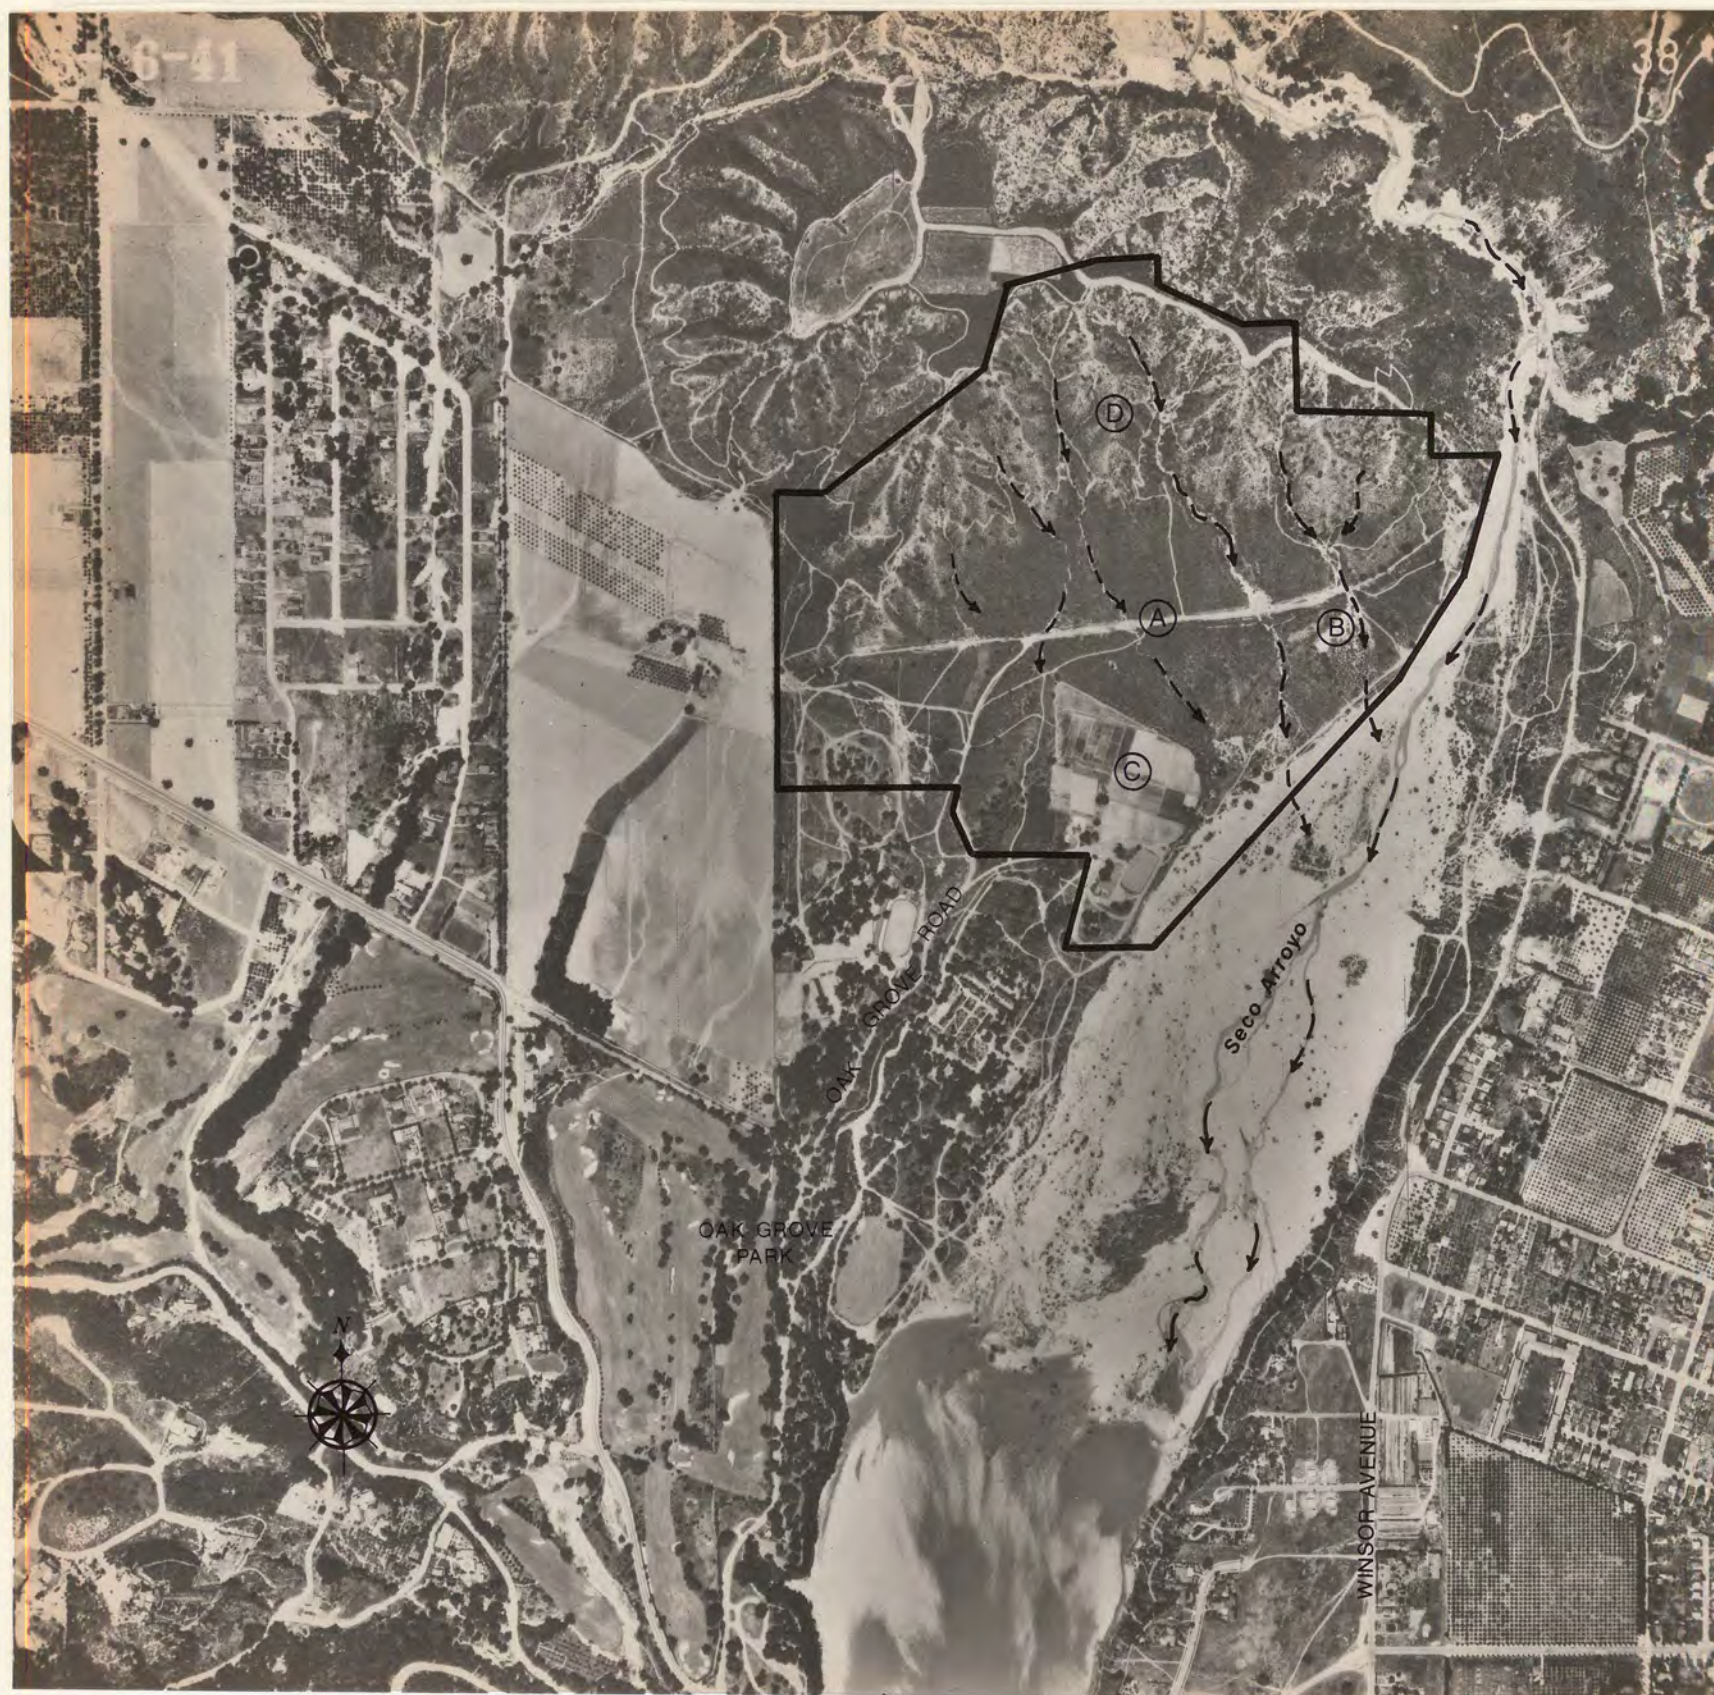
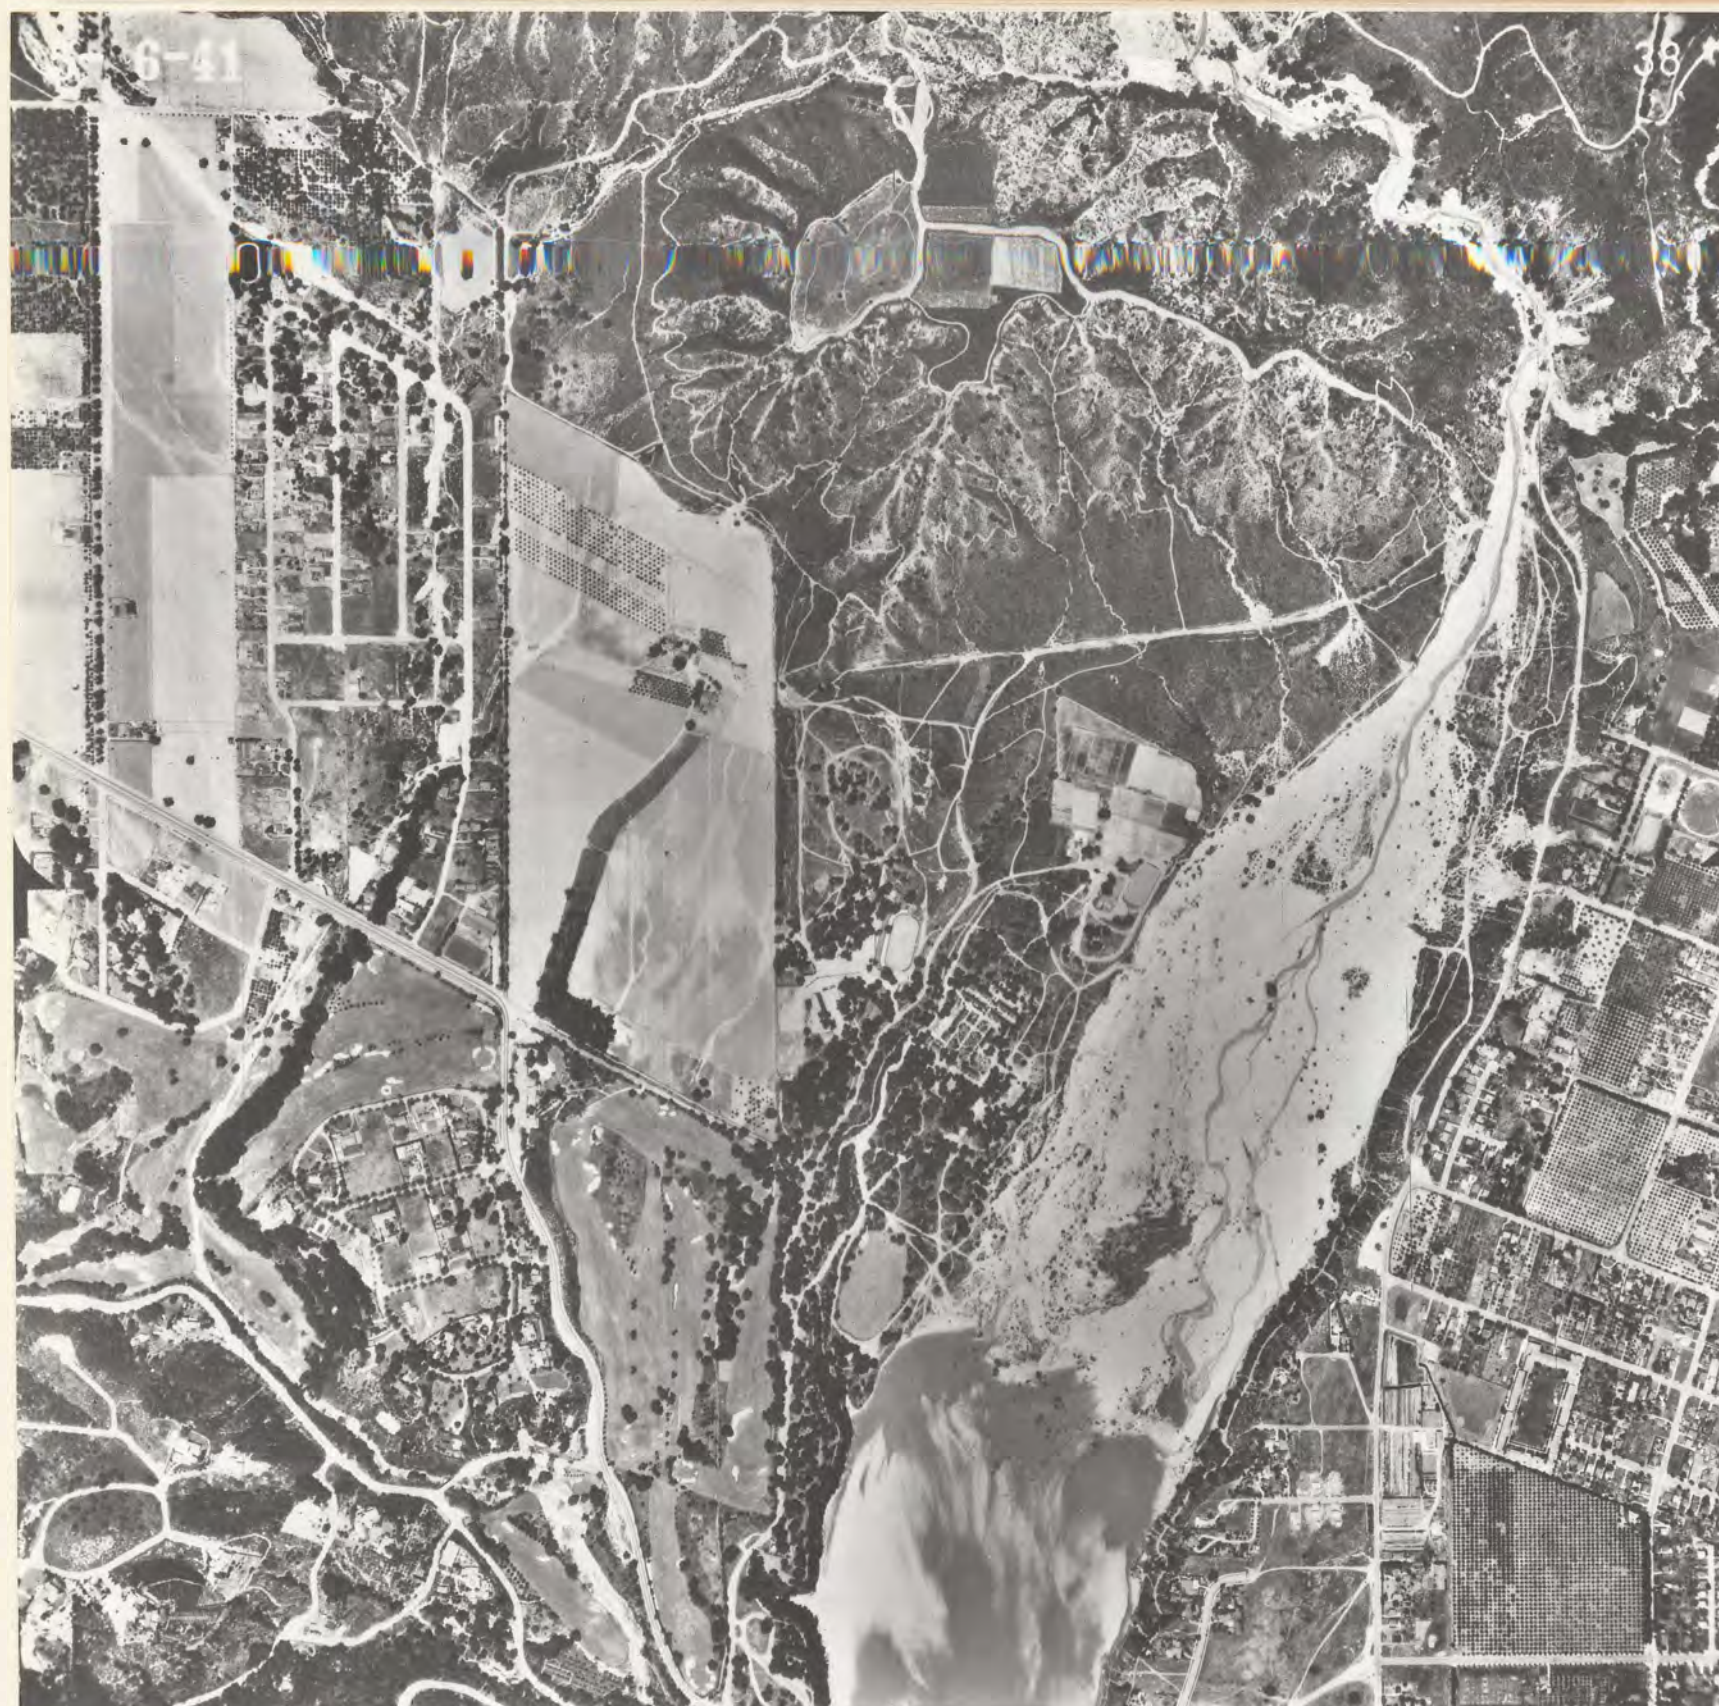
Figure 4. Future location of NASA Jet Propulsion Laboratory, May 6, 1941.  
Approximate scale 1:11,200.

The 1941 photograph shows the condition of the La Canada foothills and Seco Canyon prior to the establishment of NASA's Jet Propulsion Laboratory (JPL) facility. The annotated JPL facility boundary is based on a JPL facility map supplied by EPA Region 9 (Figure 3) and the shape of the JPL facility as observed on the 1992 photographs. The annotated boundary does not represent legal property ownership lines. The same JPL facility boundary is shown on all years of photography used in this report within the limits of using unrectified photographs and different photo scales.

An unpaved road provides vehicle access into the study area from the south via Oak Grove Road (Annotation A). This unpaved road appears to be the precursor to Explorer Road and goes to a ground scarred area, distinctive with exposed, bare earth (Annotation B). Cultivated cropland is visible in the south central portion of the study area (Annotation C). The northern portion of the study area consists of the south-facing slopes of the La Canada foothills (Annotation D). There are no discernible laboratory buildings or jet engine testing facilities. No liquid waste disposal pits, ponds, lagoons, or impoundments are identified.

Surface runoff drains down from the La Canada foothills and south, across the future JPL facility, into the Seco Arroyo via natural gullies and valleys.

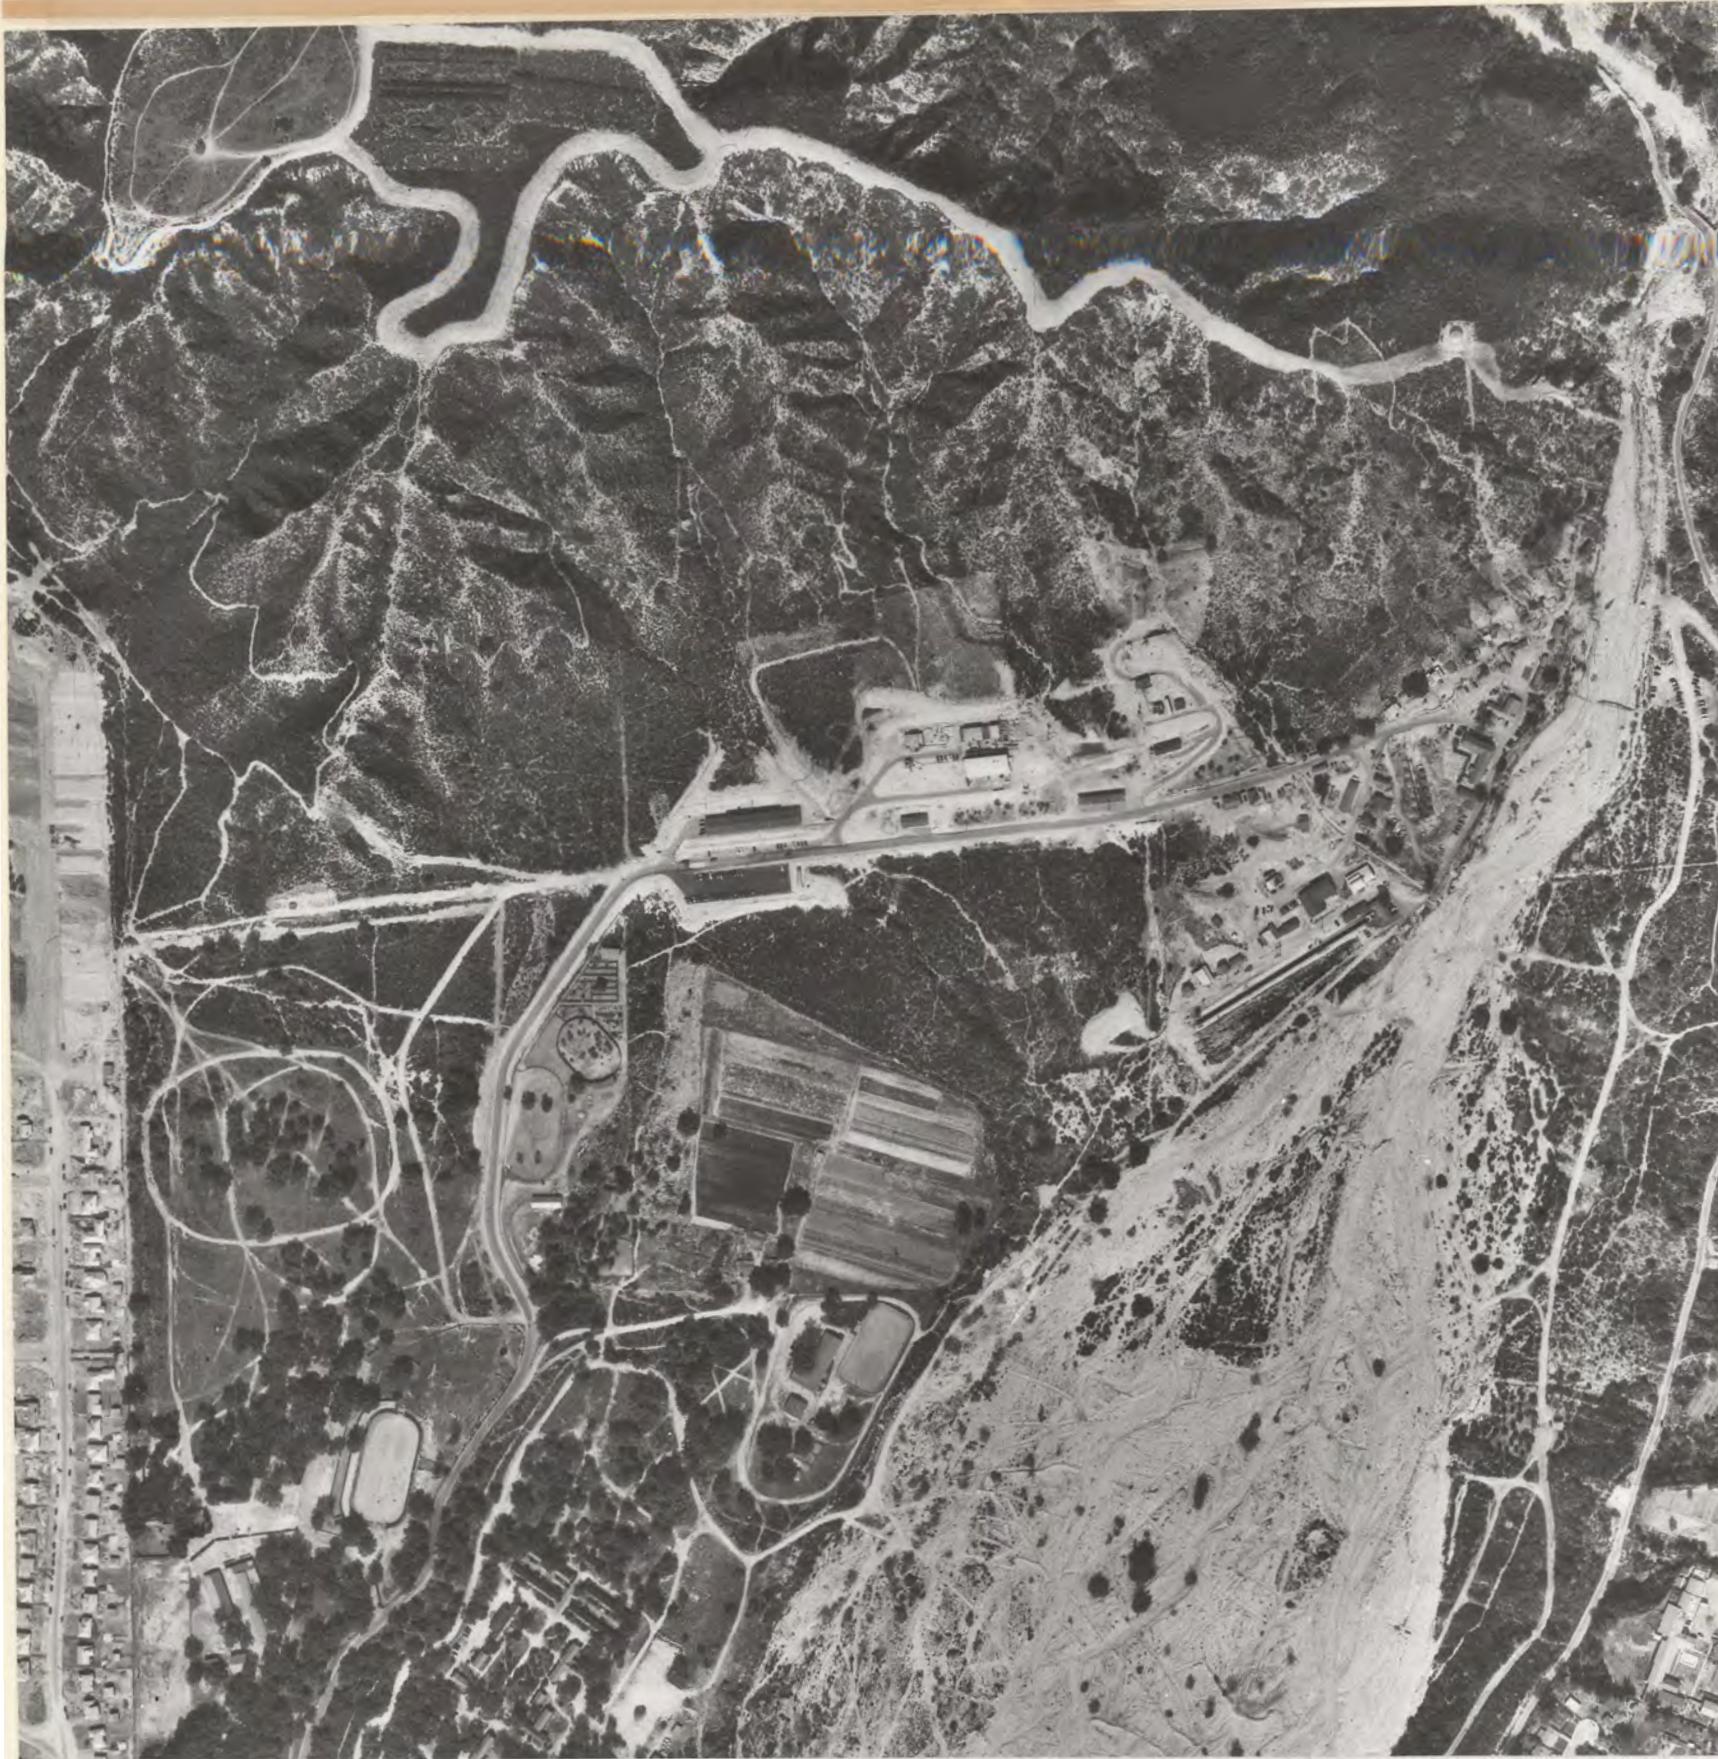
A long, concrete-lined, pool/tank filled with liquid is at the southeast portion of the study area (Annotation E). This pool/tank is possibly a test facility structure because of its close proximity to other laboratory buildings. Dark-toned material, possibly sludge, has been piled on the south side of the long pool/tank (Annotation F).

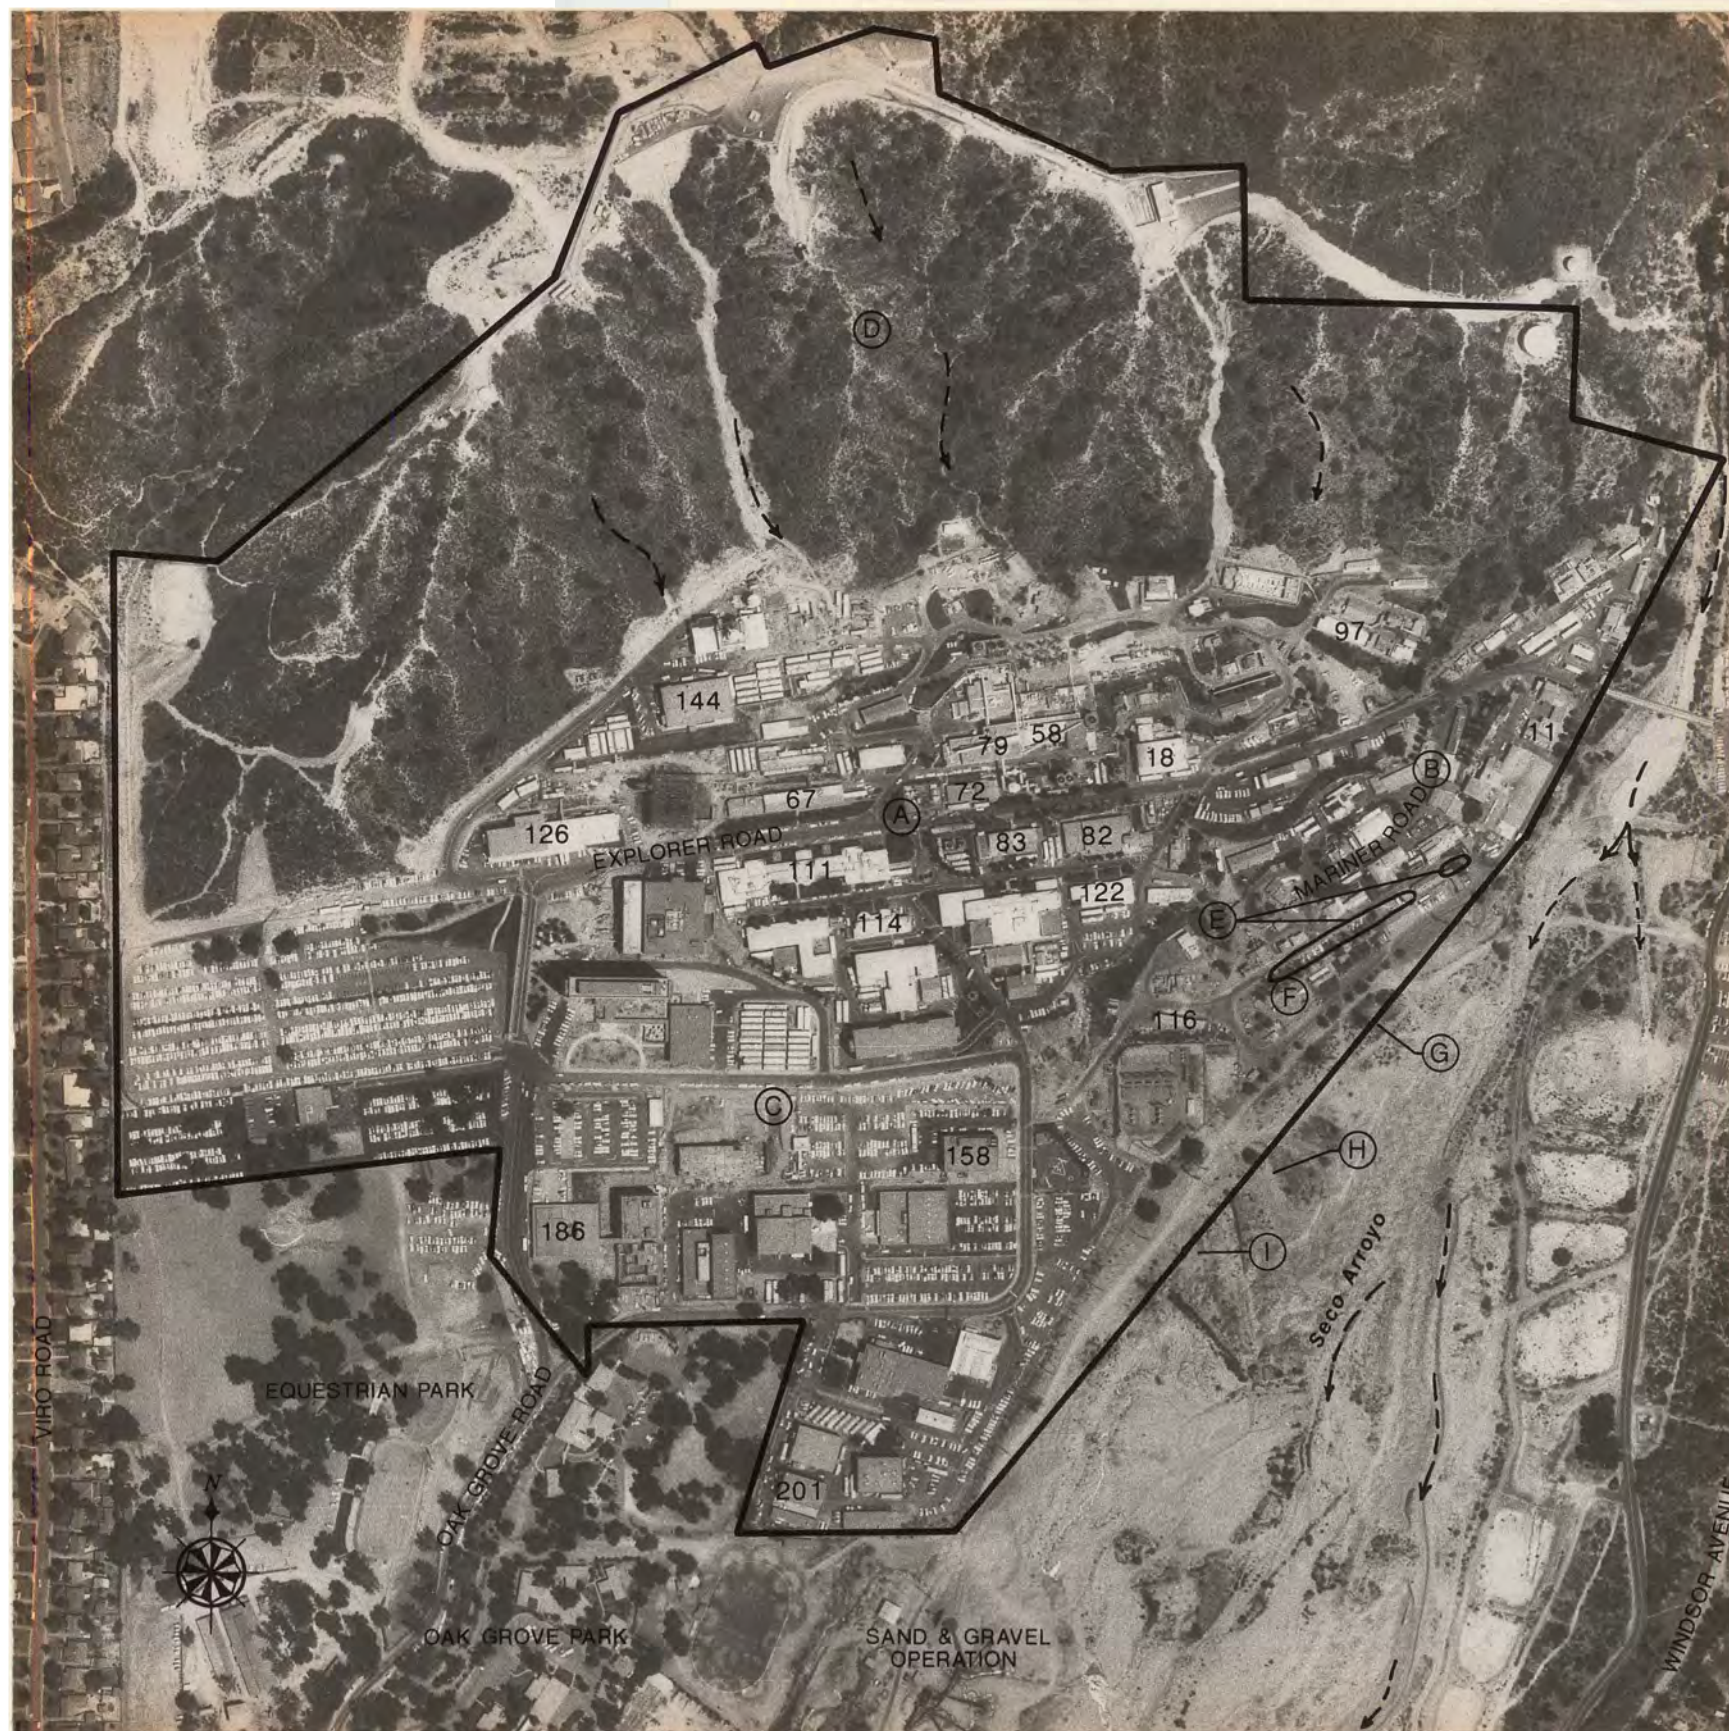
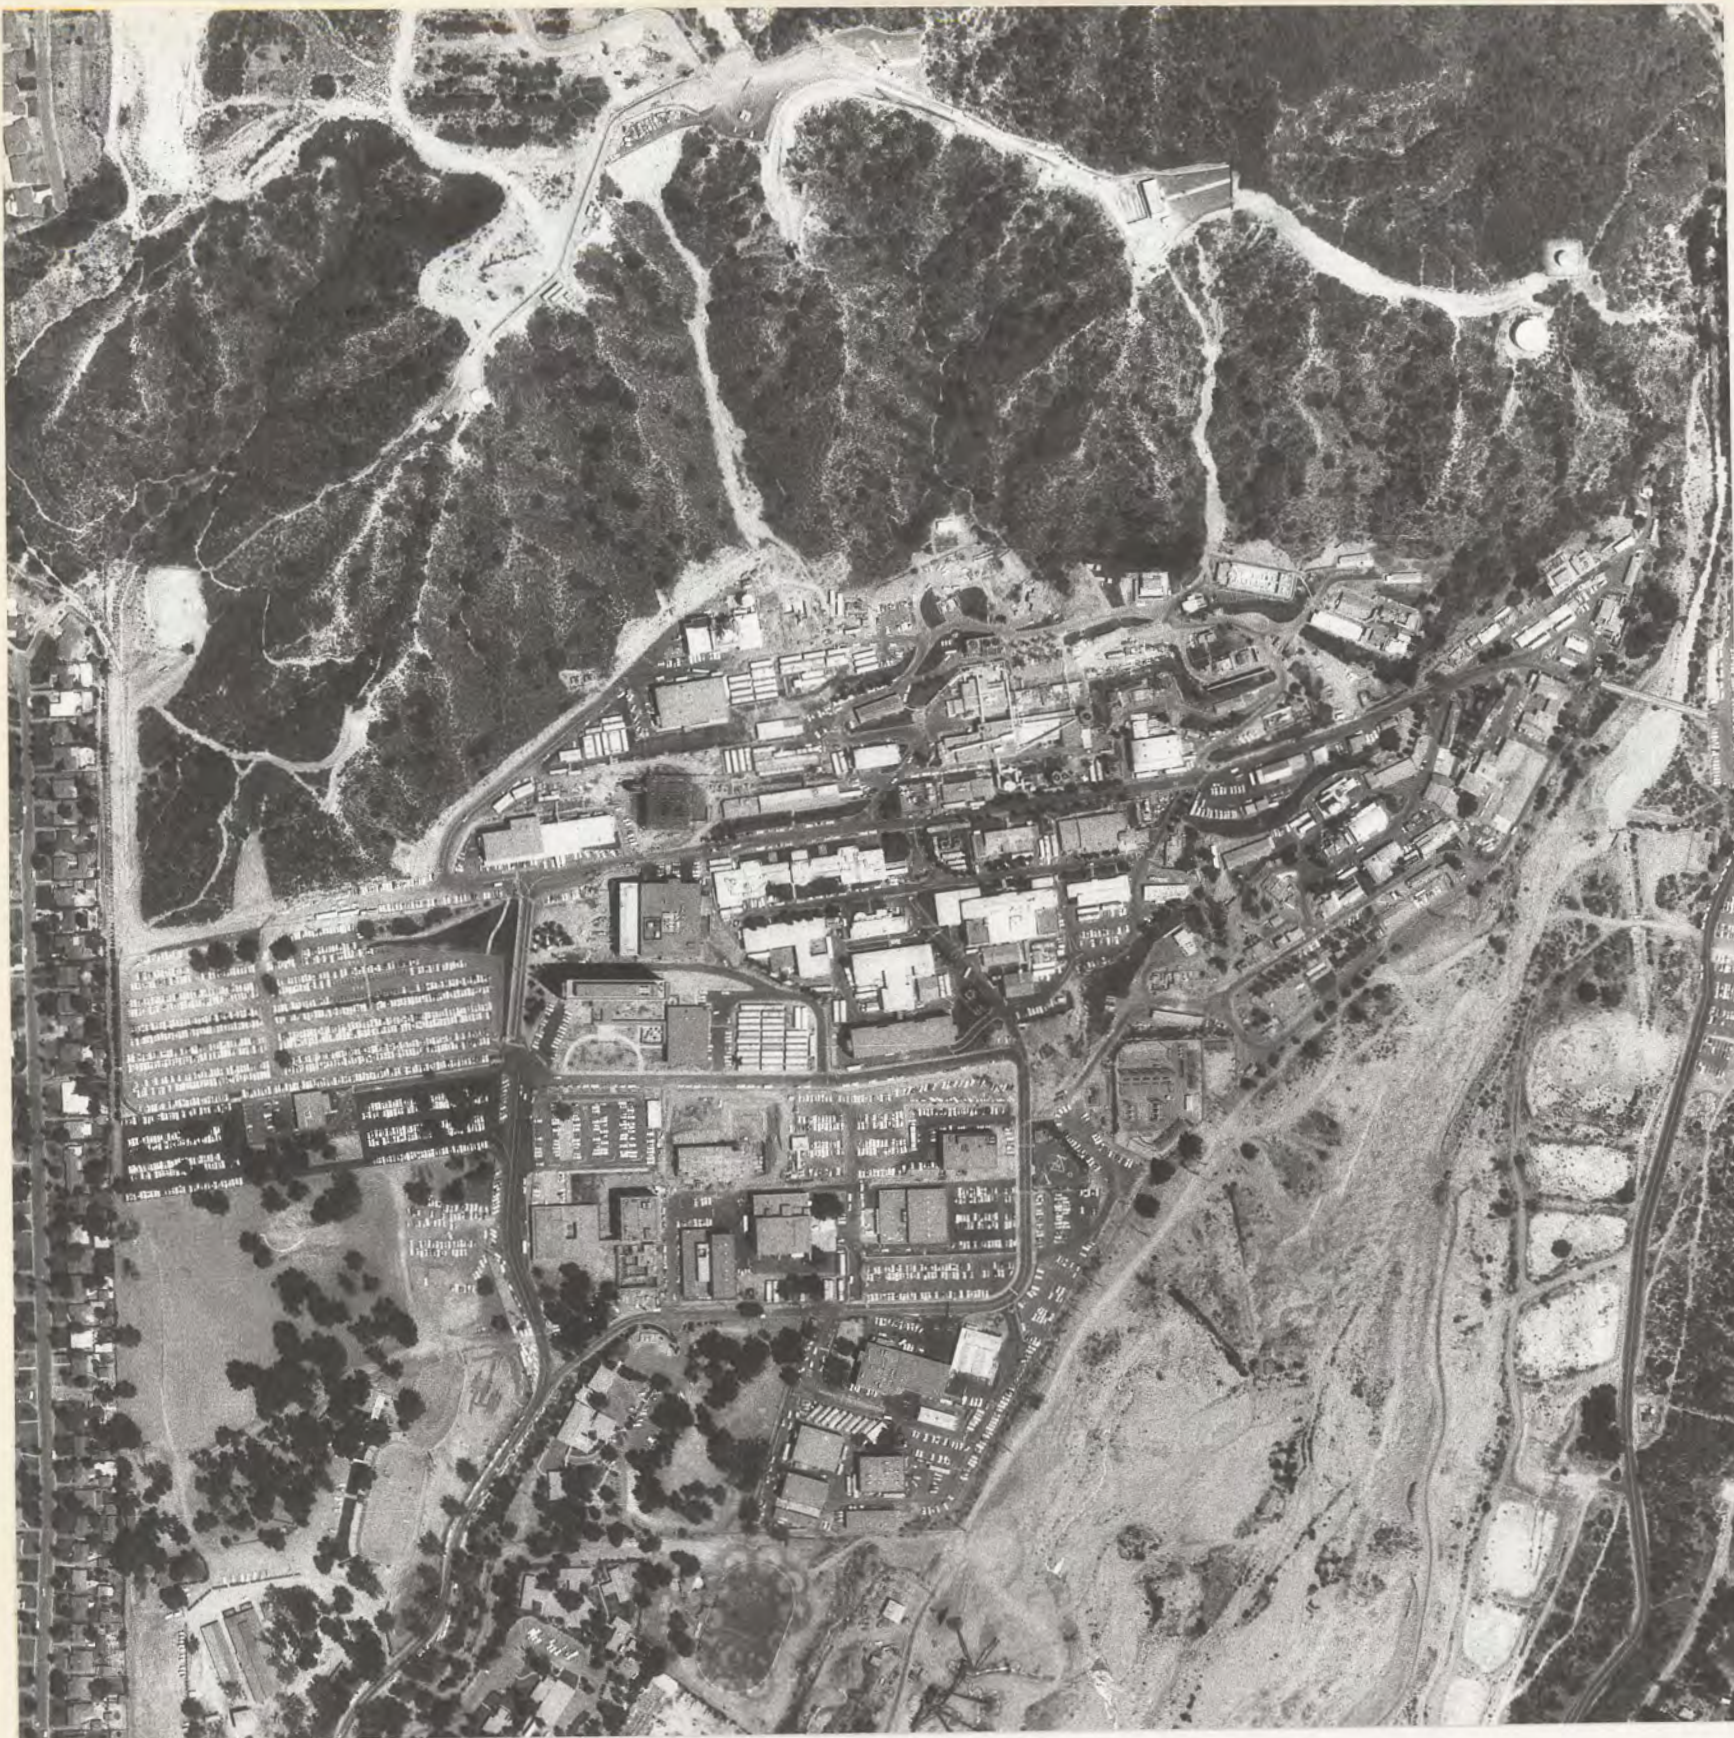
Figure 8. NASA Jet Propulsion Laboratory, July 28, 1964.  
Approximate scale 1:5,200.

The 1964 photograph reveals significant construction has occurred at the JPL facility since 1952 (Figure 7) with almost double the amount of land presently developed with buildings and parking lots. By 1964, numerous buildings have been constructed in the western and southern portions of the study site on locations that were formerly parking areas or undeveloped land since 1946 (Figures 4 through 7, Annotations C). A few of the JPL buildings first observed in 1964 are annotated as reference points (Annotations 126, 144, 158, 186, and 201). Development is also observed along the ridge-line road that runs along the JPL facility's northern perimeter.

The location of the previously reported long pool/tank is still identified by the row of adjacent trees but the pool/tank appears non-operational (Annotation E). Construction of new buildings has occurred on the previously identified area "F". The suspected waste handling/disposal pit, trench, and impoundment previously reported are not discerned due to earthmoving activity associated with construction; however, the approximate locations of these former structures are annotated (Annotations G, H, I). No operating waste disposal units are observed.

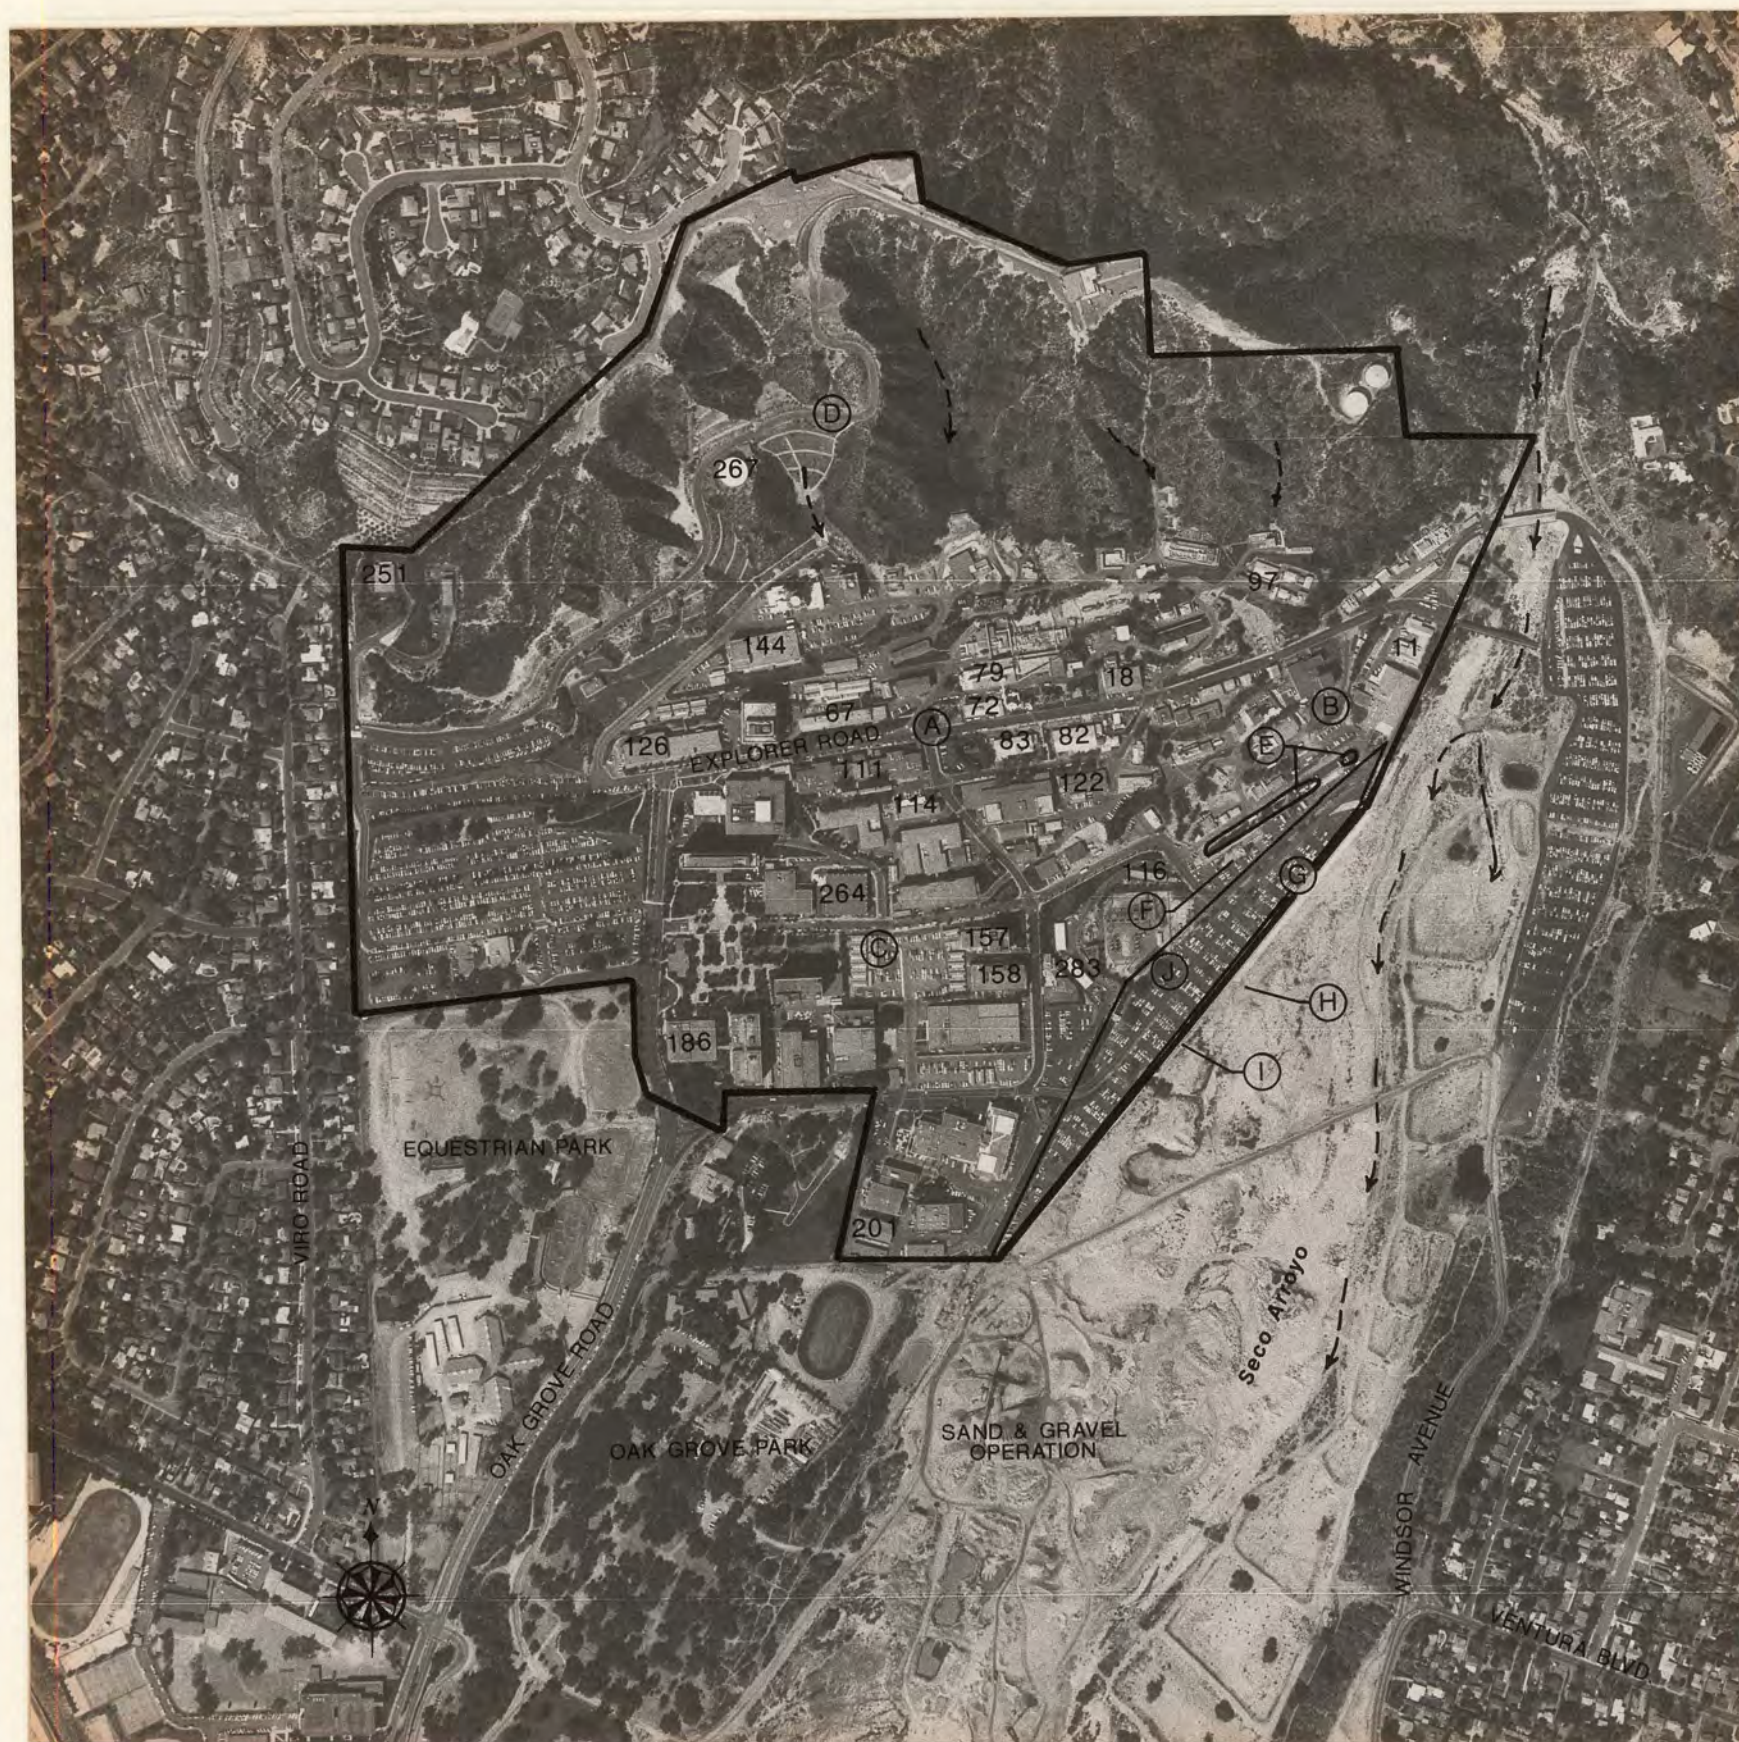
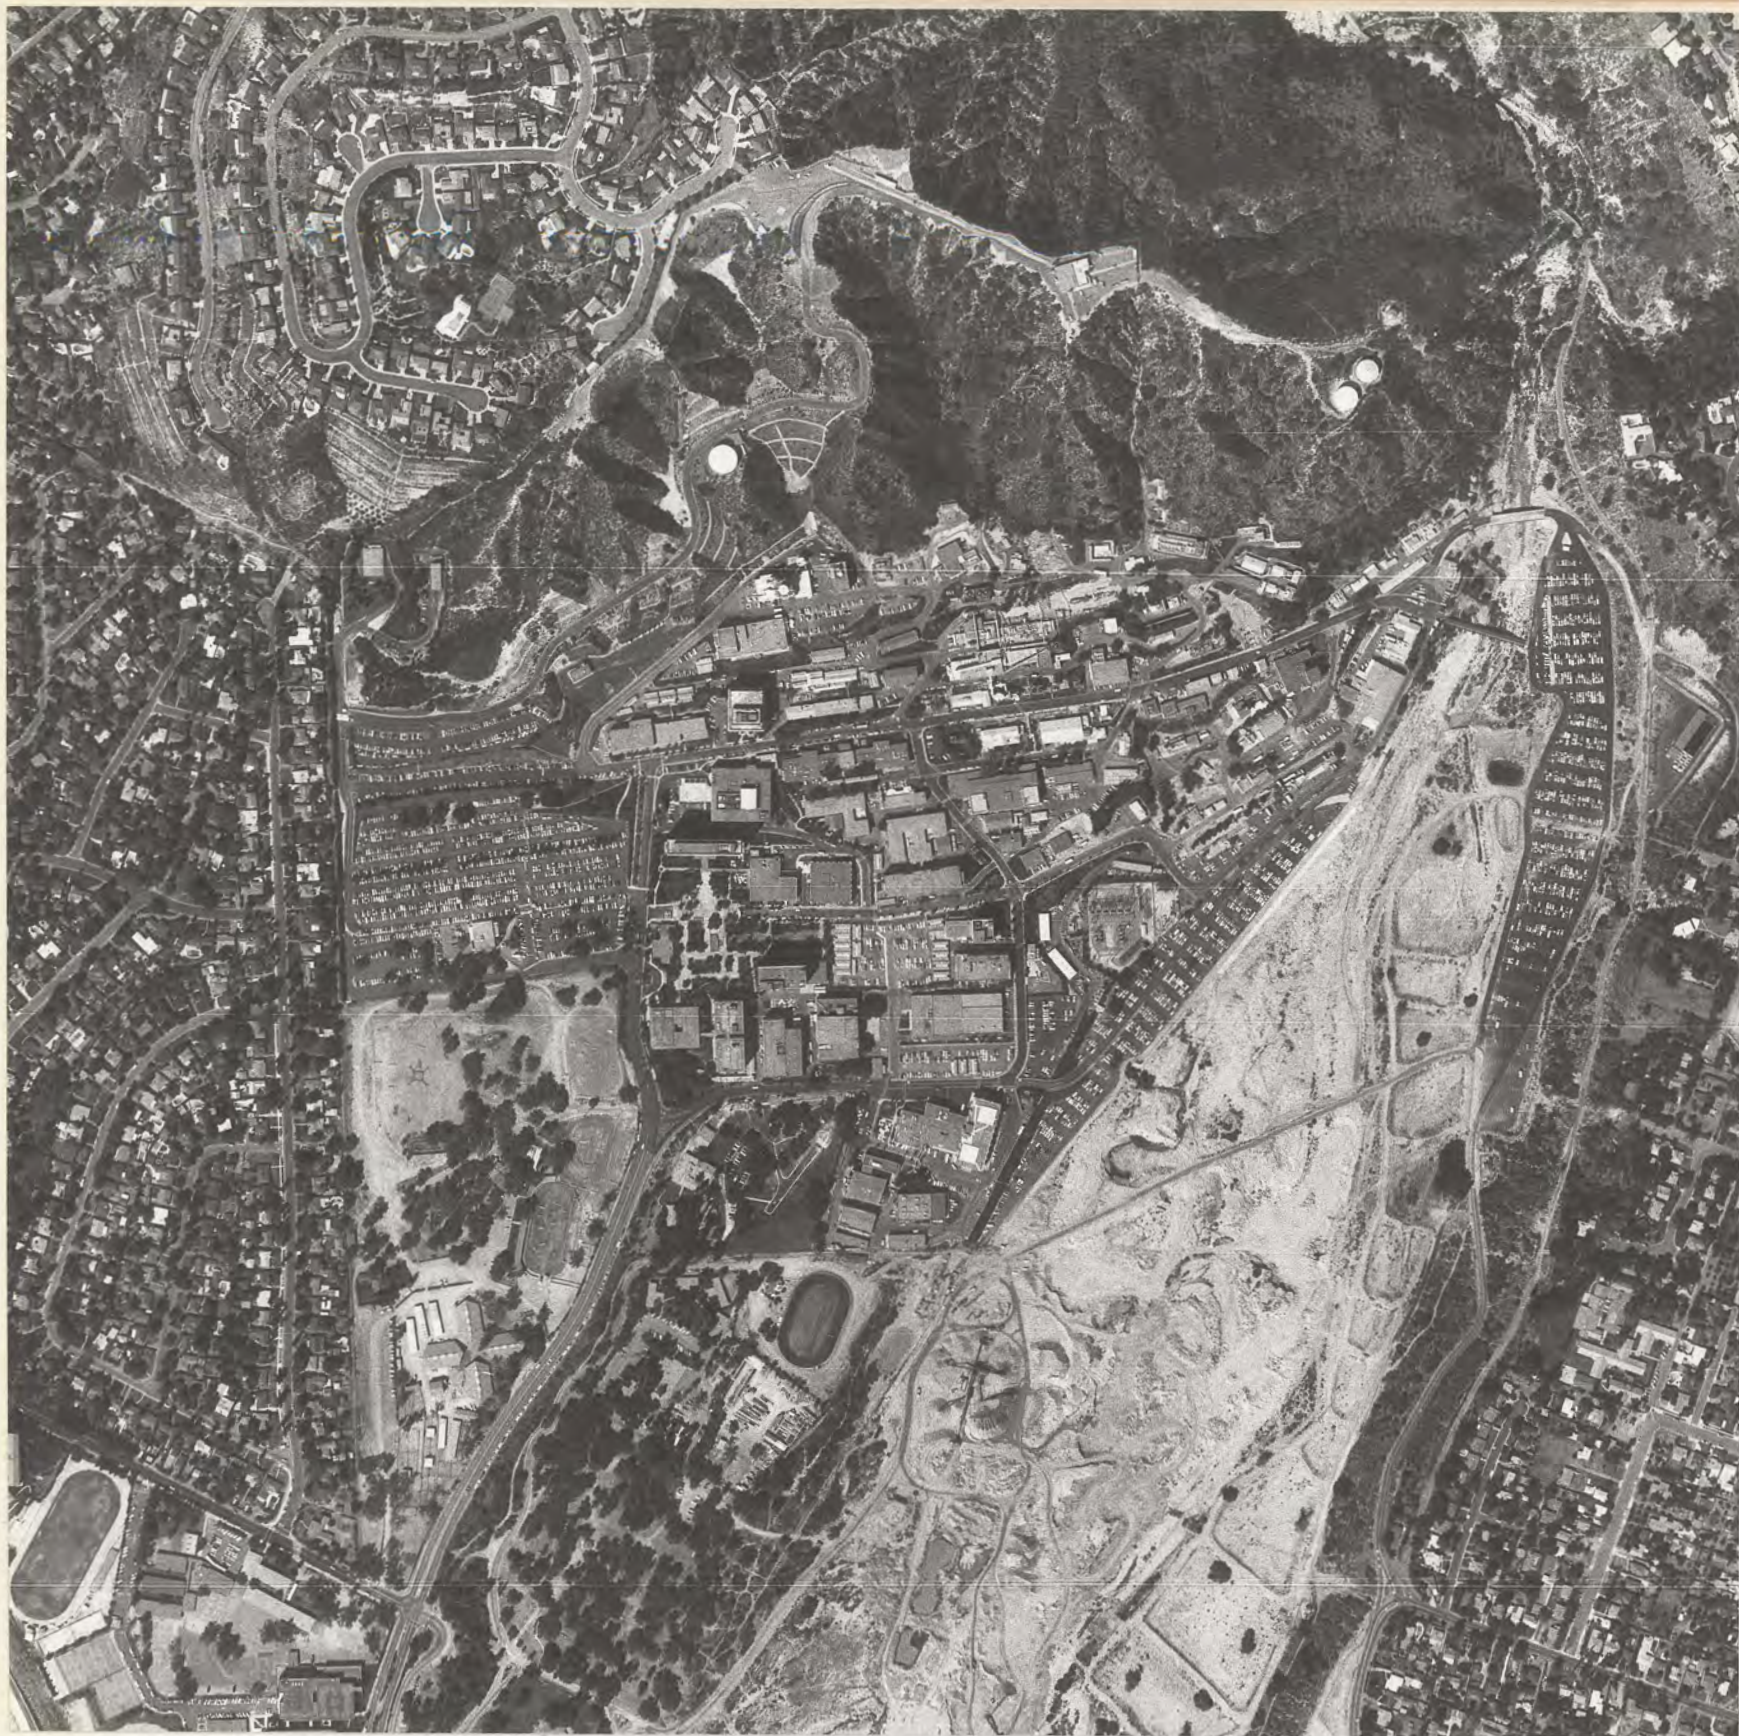
Figure 9. NASA Jet Propulsion Laboratory, September 20, 1972.  
Approximate scale 1:7,000.

The locations of previously reported features and those previously annotated JPL buildings are annotated on this photograph as reference locations (Annotations A through I). The shape and size of several of these buildings have been modified and/or demolished to make space for ongoing construction. A select group of buildings first observed in 1972 are annotated (Annotations 157, 264, and 283) in addition to those buildings first noted along the ridge-line road that runs along the JPL facility's northern perimeter (Annotations 251 and 267).

The 1972 photograph reveals continued construction since 1964 with the addition of several new parking lots; one of these is along the south end of the JPL facility, along the bank of the Seco Arroyo (Annotation J). The suspected waste handling/disposal pit, trench, and impoundment are covered with new parking lot pavement; these approximate former locations are annotated (Annotations G, H, and I). No operating waste disposal units are observed.
